Quality Assurance and Source Inspection

Contract #: 04-0120F4Cty: SF/ALA Rte: 80 PM: 13.2/13.9File #: 69.28**WELDING INSPECTION REPORT****Resident Engineer:**Pursell, Gary**Address:** 333 Burma Road**City:** Oakland, CA 94607**Report No:** WIR-001333**Date Inspected:** 20-Jul-2008**Project Name:** SAS Superstructure**OSM Arrival Time:** 600**Prime Contractor:** American Bridge/Fluor Enterprises, a JV**OSM Departure Time:** 1400**Contractor:** Zhenhua Port Machinery Company, Ltd (ZPMC), Changxing Island **Location:** Shanghai, China**CWI Name:** Xiu Zhai Gu**CWI Present:** Yes No**Inspected CWI report:** Yes No N/A**Rod Oven in Use:** Yes No N/A**Electrode to specification:** Yes No N/A**Weld Procedures Followed:** Yes No N/A**Qualified Welders:** Yes No N/A**Verified Joint Fit-up:** Yes No N/A**Approved Drawings:** Yes No N/A**Approved WPS:** Yes No N/A**Delayed / Cancelled:** Yes No N/A**Bridge No:** 34-0006**Component:** OBG and Tower Mock-up**Summary of Items Observed:**

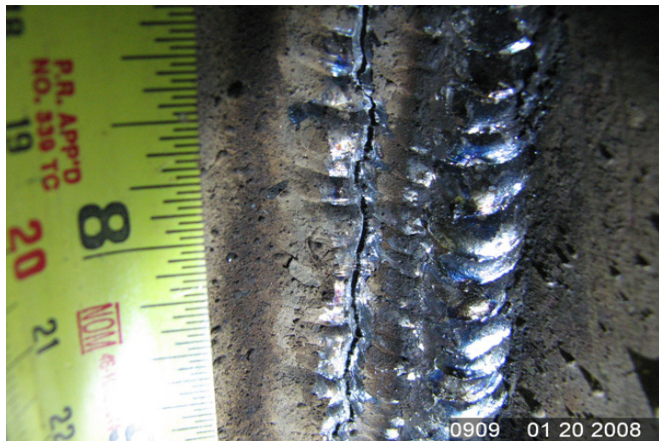
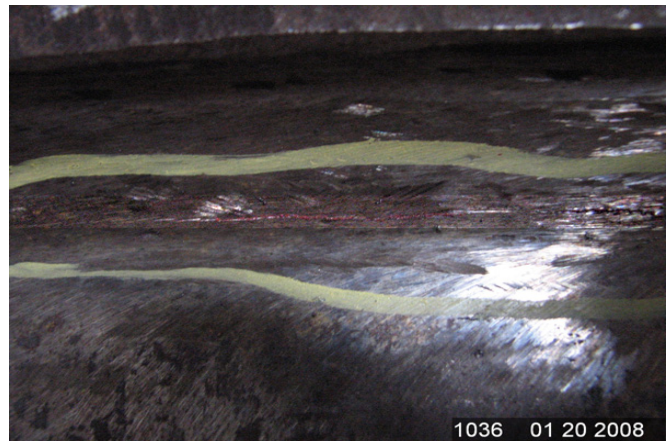
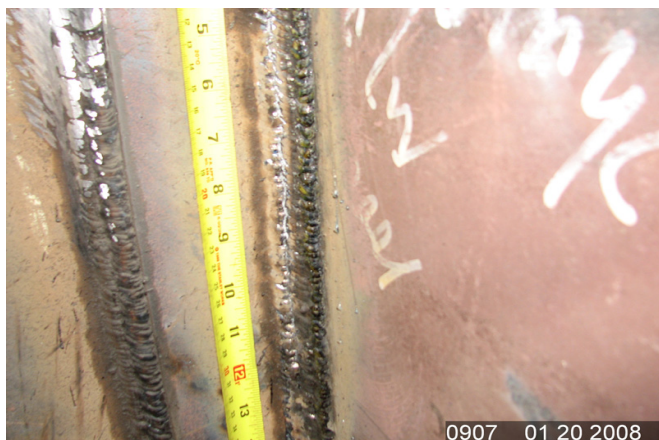
The QA inspectors discovered a total of 4 of 8 cracks at the junction of fitting lugs to diaphragms and fitting lugs to longitudinal stiffeners on Tower Mock-up 89 M (7 cracks) and 77 M (1 Crack).

Note: In the Tower Mock-up 89 M, was found cracks at the junction of the longitudinal stiffeners. See photos of the cracks; this joint was welded with 7018 electrodes (TL 508) which are not delivered in hermetically seal containers.

An incident report was issued due to ABF had allowed ZPMC to produce unsatisfactory welds that do not meet the minimum requirements for mock-up fabrication. Cracks, as defined by AWS D1.5, were found at numerous locations at the junction of the fitting lug to the longitudinal stiffeners. Weld numbers A/J 17, A/J 25, A/J 29, G/J 21, G/J 25 G/J 29 and G/J 44 on the Tower Mock-up 89 M and two locations at the junction of the fitting lug to diaphragm SA 104, joint # 36 and diaphragm to longitudinal stiffeners weld joint # 22 Tower Mock-up 77 M. These items are not in compliance with the Special Provisions, Section 10-1.59, "Fabrication/Erection Procedure and Mock-Ups", Page 313, paragraph B.1.
